# Infrastructure Projects Southern Home Safe

The Southern Region's Weekly Safety Update

20 December 2017

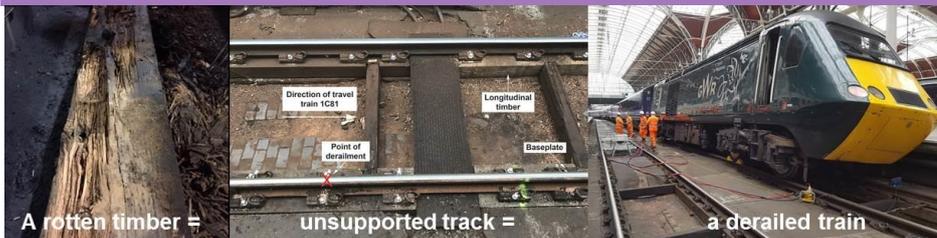
A train derailed at Platform 2, Paddington Station because the right-hand rail moved laterally under the weight of the train. This was caused by failed timbers which had been identified as needing replacement during their annual inspection in November 2016. The inspection report recommended that approximately 30 metres of the right-hand timbers should be changed 'as soon as practicable'. The report also stated that the timbers were being damaged by toilet waste and water leaking from trains. You can read the [full RAIB Safety Digest here](#).

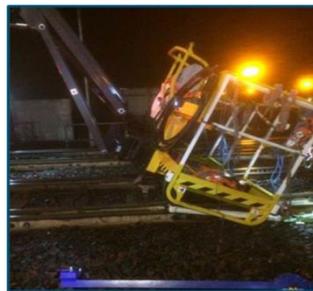
In a previous Home Safe we reported on a basket of a Road Rail Mobile Elevated Working Platform that sheared off. A fitter had recorded damage but the damage was not repaired when it was serviced. On examination after the failure, pin of the fly jib cylinder was bent sufficiently to cause a fatigue failure in the rotator bracket that connects the basket to the fly jib.

Two months passed between the initial damage and the failure. Damage to the basket is believed to have been caused by a collision whilst stabled in the compound. **The damage had been reported but not acted on.** The key safety lessons include:

- Reviewing traffic management in compounds and depots.
- Creating designated areas for MEWPs and whenever possible, stabling MEWP baskets in the elevated position.
- Plant movements in compounds to be controlled by a banksman.
- Review the process for responding to damage reports.

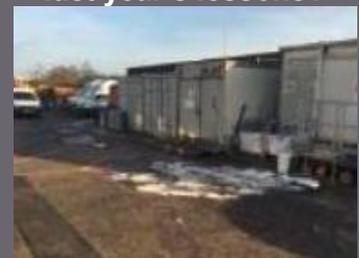
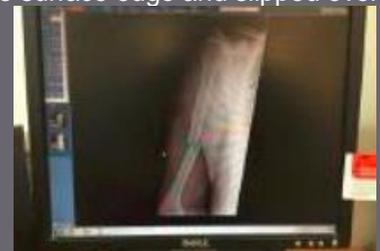
An operative working for Works Delivery was leaving the office on site when he noticed a large patch of ice. He placed a red fence around the area to warn others whilst he went to get rock salt from the store. While making his way around the icy patch, he misjudged the surface edge and slipped over.

The operative was taken to hospital where it was confirmed that he had broken his arm. The front of the depot yard had been treated with salt, but the rest of the compound had not.

- During cold winter conditions, compounds should be treated regularly with rock salt or a similar anti-ice treatment.
- Areas known to gather water should be rectified or closely monitored.
- Always ensure rock salt or similar anti-ice treatments are available on site.

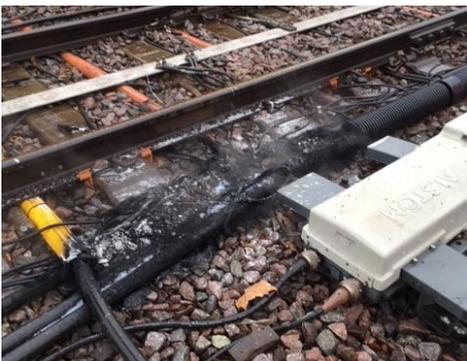
A High Voltage E and P cable in the Waterloo throat was pierced by point motor detection rods. This caused a cable fire which had very significant operational impact. It appears that the cable was located too close to the point motor.
