Infrastructure Projects Southern Home Safe

The Southern Region's Weekly Safety Update

25 October 2017

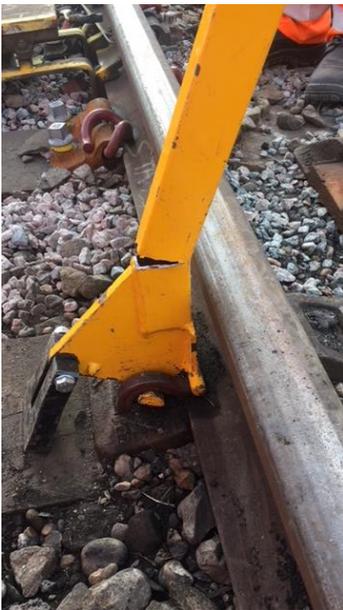
Do you regularly check your spike extractors?

Rail chair spike extractors are designed for the easy removal of spikes that hold chairs to the rails. Two instances have recently occurred on a southern region site which resulted in the spike extract bending or cracking. This has the potential to cause a fall injury to the user.

- Make regular checks of all rail chair spike extractors and quarantine any that are cracked, out of shape or otherwise damaged.
- Remind all users of spike extractors of the dangers of a catastrophic failure and to take extra care when using the tool.

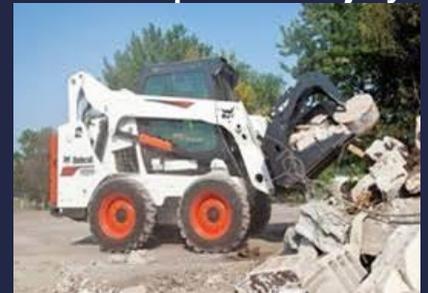
Seat belt prevents injury

A skidsteer tipped forward whilst descending a ramp when the operative applied the brakes. The operative was not injured as he was wearing a seat belt.

Always obey the speed limit and wear a seat belt.

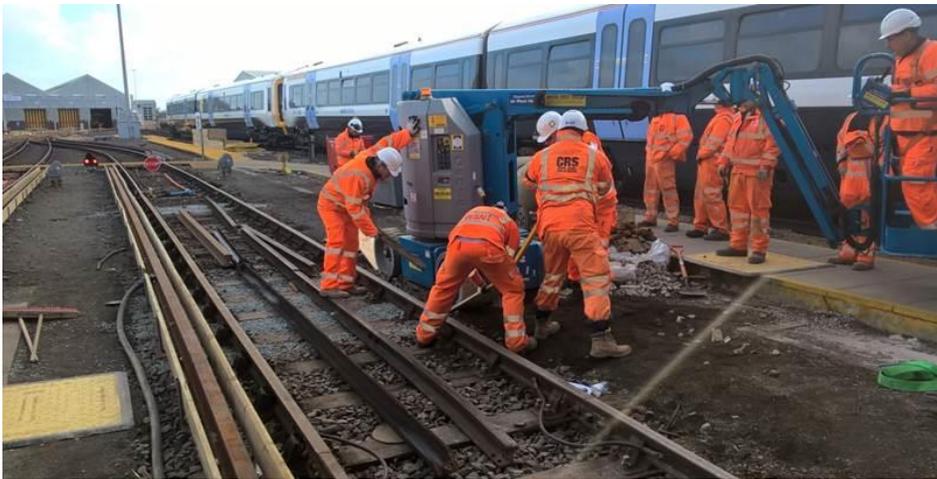
In a further incident (above), a MEWP was moved out of the depot sheds onto the ballast between two sets of lines which were under possession. It became bogged down and was unable to be moved until the next day when a recovery plan was developed. As a result, the MEWP fouled the adjacent line preventing the possession hand back for that line.

The incident is under investigation but **this type of MEWP is only suitable for operating on hard surfaces such as concrete and tarmac. It is not an all-terrain vehicle.**

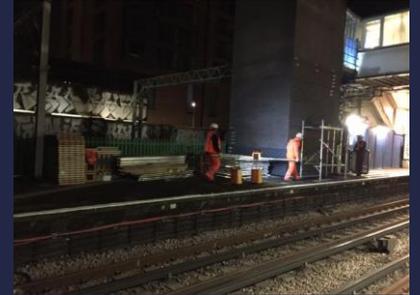
During recent construction work by TfL at Bromley-by-Bow, a metal outrigger for a tower scaffold was lifted by a worker on the westbound platform, to within 2.75 metres of the adjacent Network Rail high voltage overhead line equipment (OLE).

Although the electrical power to the OLE was off, this information had not been briefed to the individual concerned.
