Infrastructure Projects Southern Home Safe

The Southern Region's Weekly Safety Update

13 December 2017

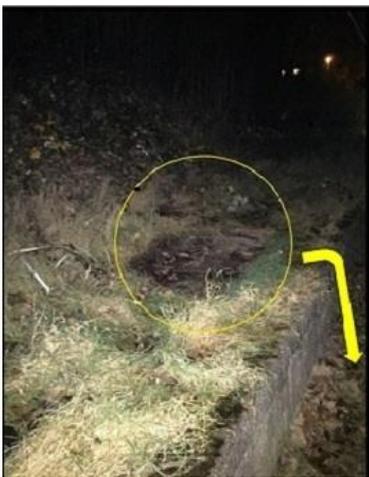
A Machine Controller working for the Anglia Route suffered two broken metatarsals when two wooden sleepers fell onto his foot.

The Machine Controller was tasked with relocating a pile of four banded sleepers from a raised retaining wall area which was adjacent to the railway track. In readiness to attach a sleeper baler, he stepped up onto the edge of the retaining wall between the sleepers to cut the banding. As he attempted to fasten the RRV attachment to the sleepers the top three sleepers toppled and the Machine Controller stumbled backwards over the retaining wall and two of the sleepers struck his foot. The accident is subject to an on-going investigation.

- Do you consider where you store materials?
- Does your risk assessment consider the environment you are working in and the stability of any materials you are moving?

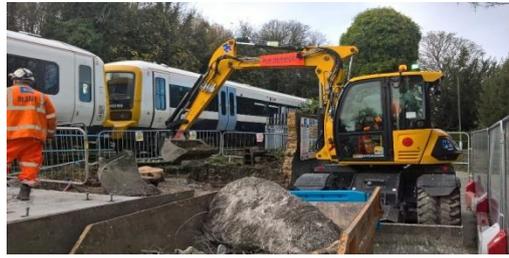
At Stone Crossing footbridge, the challenge was to find an excavator which could drive between sites and comply with ALO working restrictions in a tight and narrow layout. The JCB Hydradig was selected by Costain as a versatile and cutting-edge machine capable of performing all the required tasks.

The excavator allowed great visibility with zero tail swing and smooth operational control. It was ideally suited to working under ALO conditions as it was physically unable to touch the 'envelope of influence' from its working position on the road. Banksmen also used

Det-Comms to talk to the driver and everyone on site was briefed on safe exclusion zone working and the 'thumbs up' rule.
