Infrastructure Projects Southern Home Safe

The Southern Region's Weekly Safety Update

27 December 2017

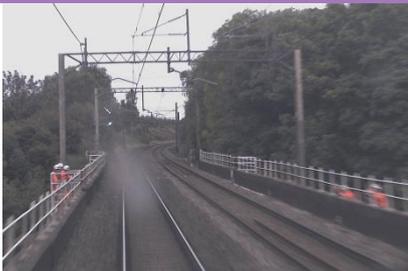
A passenger train travelling at 125 mph encountered three lineside workers on Dutton Viaduct. The last of the workers moved clear of the track less than half a second before the train passed him. None of the workers were injured but the train driver was shaken by the incident.

Because of the limited space available on the viaduct to stand clear of passing trains, the viaduct is a 'red zone prohibited area'. This means that railway staff are not permitted to be on the viaduct whilst the railway is open to traffic unless they are separated from trains by a permanent fence. Despite the prohibition of access to the railway lines on the viaduct while trains are running, the group of workers chose to cross from a refuge on the down side of the railway to a refuge on the up side of the railway. The line-side workers did not report the incident as a near miss to the signaller or their employer.

Safety lesson...one of the lessons raised by the [Rail Accident Investigation Branch Safety Digest](#) was the importance of challenging unsafe behaviours within a work group, even if the person in charge of safety has instigated or agreed to an unsafe act. **Would you invoke Worksafe or take a Time Out Take Five in these circumstances?**

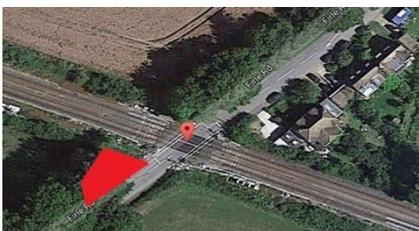
The crossing near Firle in Sussex is a useful access point, with small parking bay (marked in red) which is often used for the storage of plant or material prior to works. On the other side of the crossing are some residential houses.

There were six complaints about vehicles parked outside houses overnight rather than the other side of the crossing and a crane delivering material caused serious damage to a tree and fencing. During repair works, litter was found which included gloves and meal packaging.

Remember: part of our safety vision is that our work environments will be tidy – **and we will leave them tidy when we've finished.**

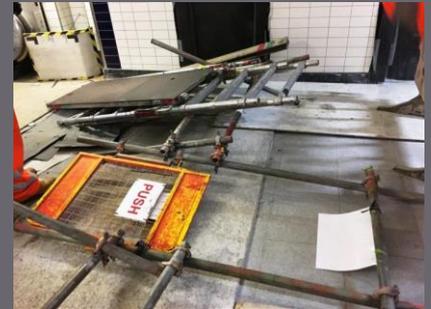
An A-frame scaffold barrier had been established at the base of escalators to assist with access control on to the escalators and the surrounding work site. An aluminium tower, weighing approximately 95Kg, was leant against the "A" frame scaffold barrier.

An operative accessing the area of the escalators, passed through the pedestrian opening in the "A"-frame. At this moment the scaffold barrier toppled over striking the operative's hardhat and causing a laceration to his back. The operative attended hospital and was subsequently off work for over four weeks.

An investigation found that the scaffold barrier toppled over due to instability caused by materials being incorrectly leant against it; there was no evidence of collapse or failure of any part of the A-frame barrier.

Safety lessons included:

- Would alternative barriers, such as Turtle gate barriers, be more suitable for task?
- Are warning signs, instructing staff not to lean materials on barriers prominently displayed?
- Are your Scaffold "A" frame barriers included on the scaffold register for site and checked weekly?
